Assessment of Crown Land Frontages in Urban Zones

- Final
- 21 September 2005

1. Introduction

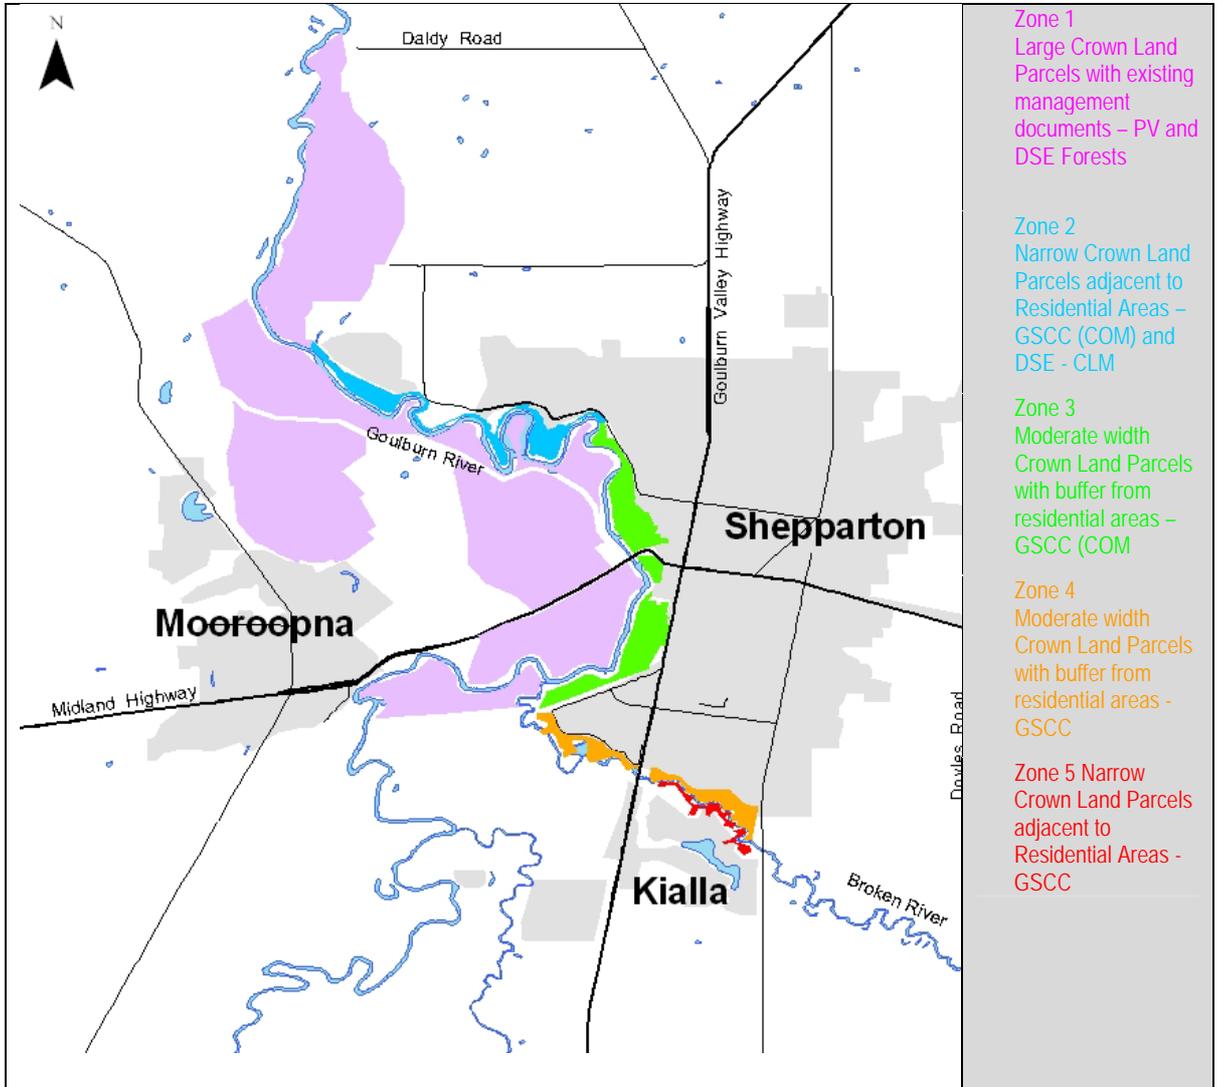
Figure 2 Proposed Urban Crown Land Management Zones

The current condition of Urban Crown Land Parcels is generally a function of the land tenure type, historical development and its location. Consequently it is recommended that Management Actions for Urban Crown Land Parcels be grouped into management zones with several Crown Land Parcels in each of these zones.

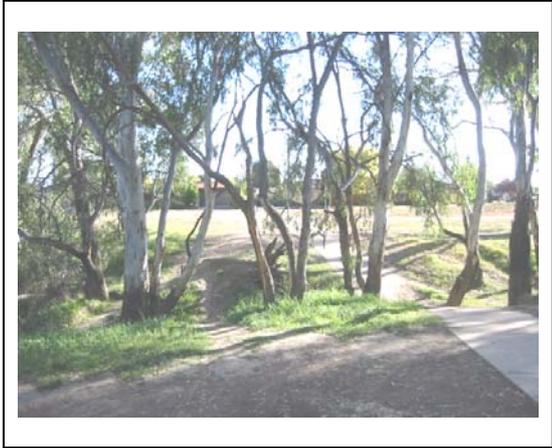
Site 1.1
Tenure Type – GSCC Reserve

CWF Vegetation Quality Assessment	
Vegetation Width	5
Soil Disturbance	3
Tree Health	3
Tree Regeneration	4
Weed Presence	1
Species Richness	2
Vegetation Structure	2
Total	20

CWF Quality Class = **Moderate**

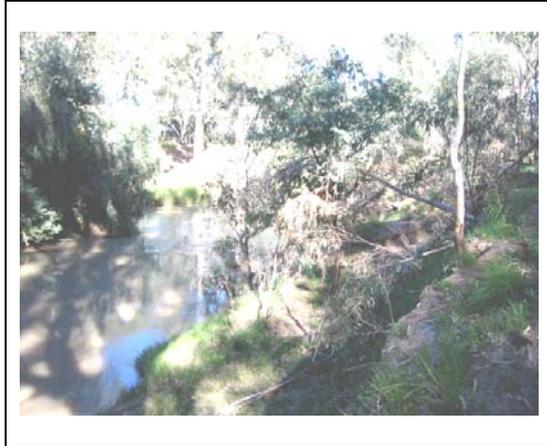
Site 1.2
Tenure Type – GSCC Reserve

CWF Vegetation Quality Assessment	
Vegetation Width	5
Soil Disturbance	2
Tree Health	4
Tree Regeneration	3
Weed Presence	4
Species Richness	4
Vegetation Structure	3
Total	25

CWF Quality Class = **Good**

- Control recreational activities particularly uncontrolled access to site
- Enforce existing legislation regarding littering and rubbish dumping
- Ensure that unauthorised timber removal does not occur
- Implement revegetation programs to improve quality of native understorey

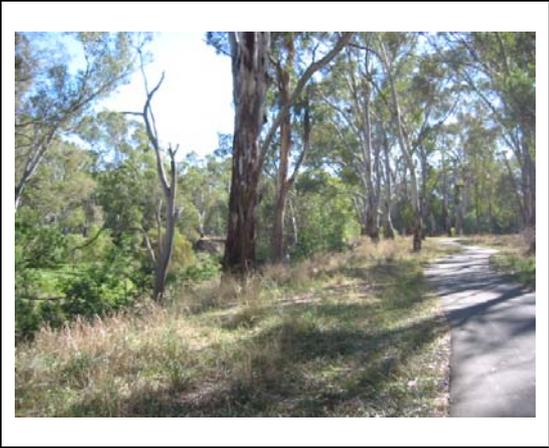
Site 1.3
Tenure Type – Unlicensed Crown Water Frontage

CWF Vegetation Quality Assessment	
Vegetation Width	5
Soil Disturbance	4
Tree Health	3
Tree Regeneration	1
Weed Presence	2
Species Richness	4
Vegetation Structure	1
Total	20

CWF Quality Class = **Moderate**

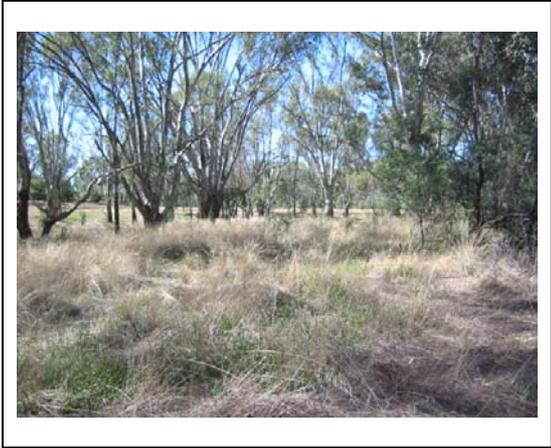
Site 1.4
Tenure Type – GSCC Reserve

CWF Vegetation Quality Assessment	
Vegetation Width	5
Soil Disturbance	4
Tree Health	4
Tree Regeneration	1
Weed Presence	3
Species Richness	2
Vegetation Structure	3
Total	22

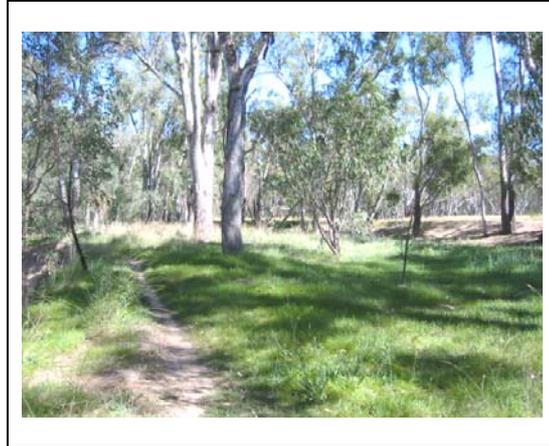
Site 1.5
Tenure Type – GSCC Reserve

CWF Vegetation Quality Assessment	
Vegetation Width	5
Soil Disturbance	4
Tree Health	4
Tree Regeneration	2
Weed Presence	2
Species Richness	1
Vegetation Structure	2
Total	20

CWF Quality Class = **Moderate**

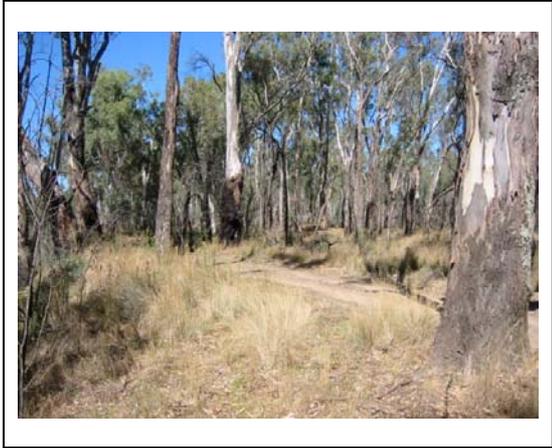
Site 1.6
Tenure Type – PV Managed State Forest

CWF Vegetation Quality Assessment	
Vegetation Width	5
Soil Disturbance	4
Tree Health	2
Tree Regeneration	3
Weed Presence	3
Species Richness	4
Vegetation Structure	2
Total	23

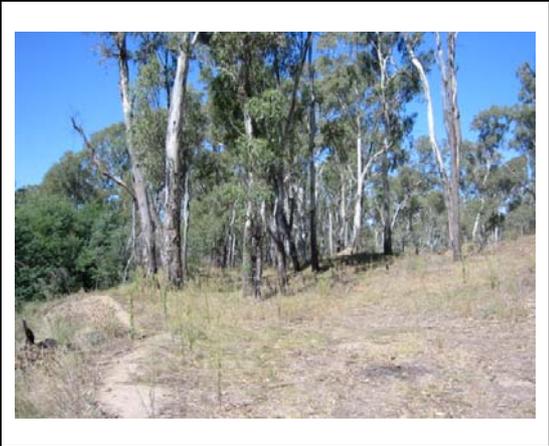
Site 1.7
Tenure Type – PV Managed State Forest

CWF Vegetation Quality Assessment	
Vegetation Width	5
Soil Disturbance	2
Tree Health	3
Tree Regeneration	1
Weed Presence	3
Species Richness	4
Vegetation Structure	2
Total	20

CWF Quality Class = **Moderate**

- Priority Actions to achieve Minimum Acceptable Standards:**
- Manage weeds, particularly environmental weed species.
 - Control recreational activities particularly uncontrolled access to site, multiple campsite locations and new off road tracks
 - Enforce existing legislation regarding littering and rubbish dumping
 - Ensure that unauthorised timber removal or timber harvesting does not occur
 - Implement revegetation programs to improve quality of native understorey
 - Ensure that grazing by stock continues to be excluded

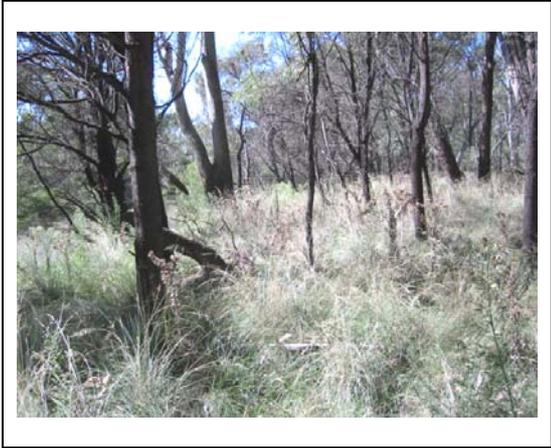
Site 1.8
Tenure Type – Licensed State Forest

CWF Vegetation Quality Assessment	
Vegetation Width	5
Soil Disturbance	4
Tree Health	3
Tree Regeneration	1
Weed Presence	2
Species Richness	2
Vegetation Structure	2
Total	19

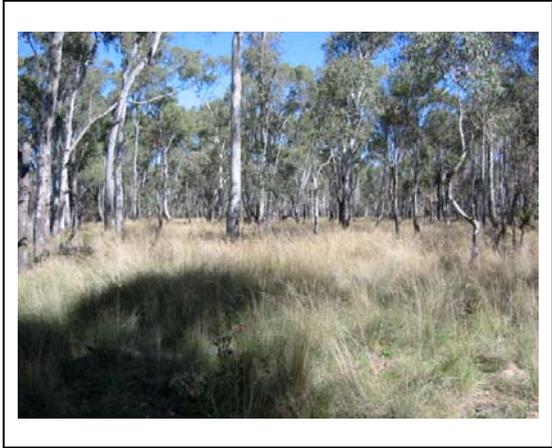
Site 1.9
 Tenure Type – Licensed State Forest

CWF Vegetation Quality Assessment	
Vegetation Width	5
Soil Disturbance	4
Tree Health	3
Tree Regeneration	1
Weed Presence	2
Species Richness	2
Vegetation Structure	2
Total	19

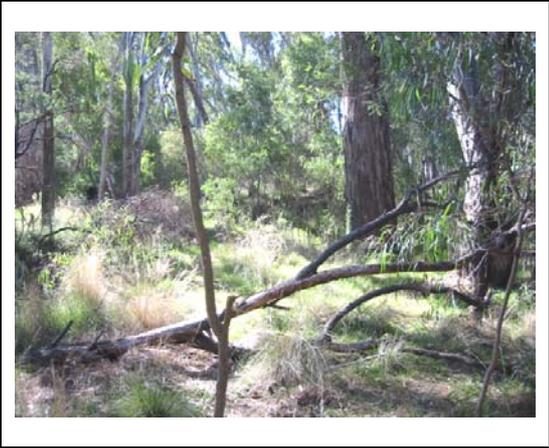
1.10
Tenure Type – GSCC Committee of Management

CWF Vegetation Quality Assessment	
Vegetation Width	5
Soil Disturbance	3
Tree Health	3
Tree Regeneration	2
Weed Presence	1
Species Richness	1
Vegetation Structure	1
Total	16

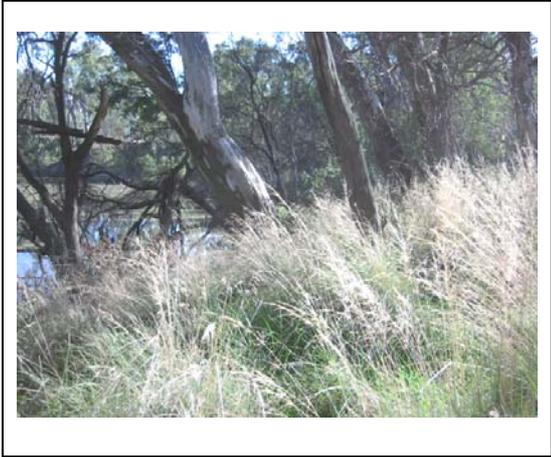
2.1
Tenure Type – PV Wildlife Reserve

CWF Vegetation Quality Assessment	
Vegetation Width	5
Soil Disturbance	4
Tree Health	3
Tree Regeneration	1
Weed Presence	2
Species Richness	2
Vegetation Structure	3
Total	20

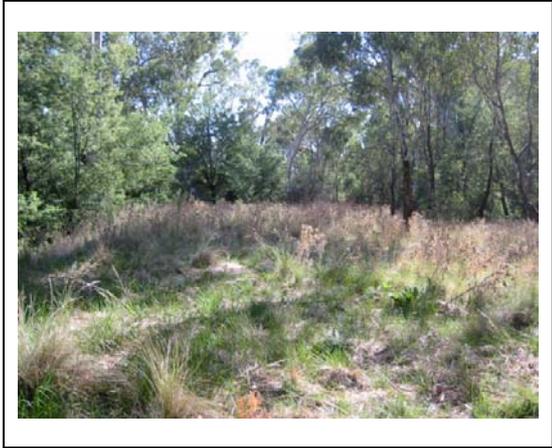
Site 2.2
Tenure Type – PV Wildlife Reserve

CWF Vegetation Quality Assessment	
Vegetation Width	5
Soil Disturbance	2
Tree Health	4
Tree Regeneration	2
Weed Presence	2
Species Richness	2
Vegetation Structure	2
Total	19

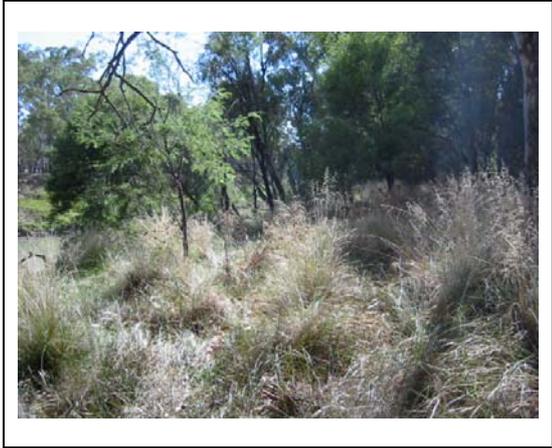
Site 2.3
Tenure Type – Unlicensed Crown Water Frontage

CWF Vegetation Quality Assessment	
Vegetation Width	5
Soil Disturbance	4
Tree Health	4
Tree Regeneration	2
Weed Presence	2
Species Richness	2
Vegetation Structure	3
Total	22

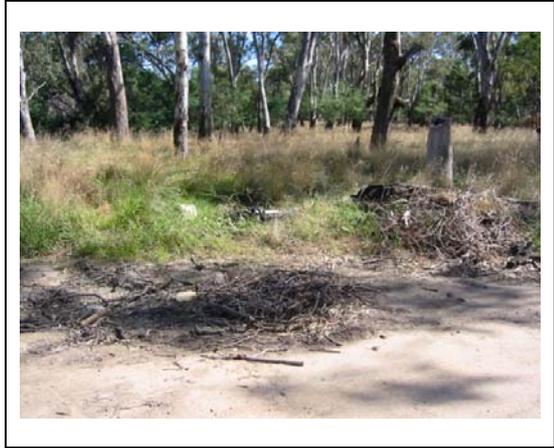
Site 2.4
Tenure Type – Unlicensed DSE Reserve

CWF Vegetation Quality Assessment	
Vegetation Width	5
Soil Disturbance	2
Tree Health	3
Tree Regeneration	1
Weed Presence	1
Species Richness	1
Vegetation Structure	2
Total	15

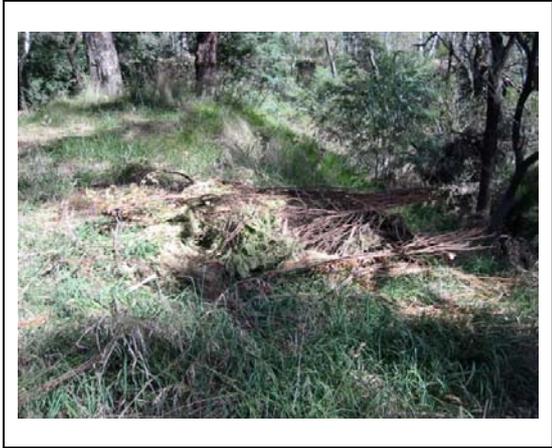
Site 2.5
Tenure Type – Unlicensed DSE Reserve

CWF Vegetation Quality Assessment	
Vegetation Width	5
Soil Disturbance	2
Tree Health	3
Tree Regeneration	1
Weed Presence	1
Species Richness	3
Vegetation Structure	2
Total	17

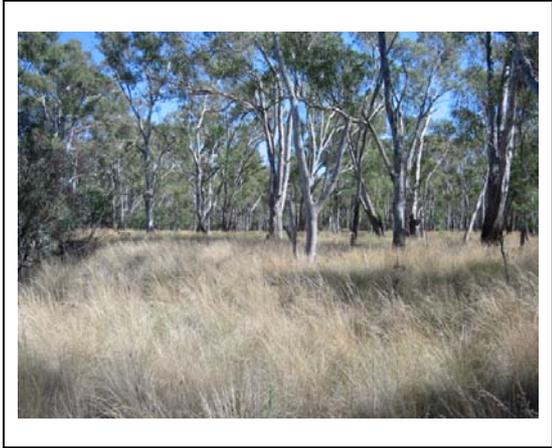
Site 2.6
Tenure Type – Unlicensed Crown Water Frontage

CWF Vegetation Quality Assessment	
Vegetation Width	5
Soil Disturbance	4
Tree Health	3
Tree Regeneration	1
Weed Presence	4
Species Richness	5
Vegetation Structure	3
Total	25

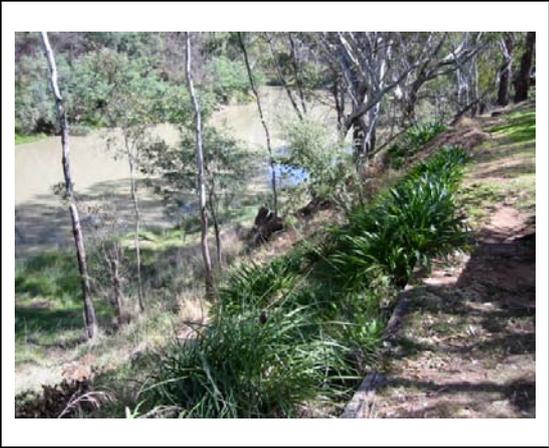
Site 2.7
Tenure Type – Unlicensed Crown Water Frontage

CWF Vegetation Quality Assessment	
Vegetation Width	1
Soil Disturbance	2
Tree Health	3
Tree Regeneration	2
Weed Presence	1
Species Richness	1
Vegetation Structure	1
Total	11

CWF Quality Class = **Very Poor**

- Priority Actions to achieve Minimum Acceptable Standards:**
- Define public/private land boundary
 - Enforce existing legislation regarding littering and rubbish dumping
 - Manage weeds, particularly environmental weed species.
 - Control recreational activities particularly uncontrolled access to site
 - Ensure that unauthorised timber removal does not occur
 - Implement revegetation programs to improve quality of native understorey
 - Undertake community education program

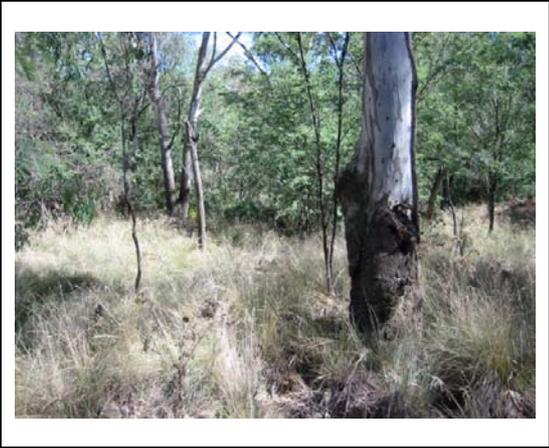
Site 2.8
Tenure Type – Licensed State Forest

CWF Vegetation Quality Assessment	
Vegetation Width	5
Soil Disturbance	4
Tree Health	2
Tree Regeneration	2
Weed Presence	3
Species Richness	2
Vegetation Structure	4
Total	22

CWF Quality Class = **Moderate**

- Priority Actions to achieve Minimum Acceptable Standards:**
- Define public/private land boundary
 - Enforce existing legislation regarding littering and rubbish dumping
 - Manage weeds, particularly environmental weed species.
 - Ensure that unauthorised timber does not occur
 - Implement revegetation programs to improve quality of native understorey
 - Undertake community education program
 - Develop grazing management plan for site to ensure that grazing by domestic stock does not compromise values of the site

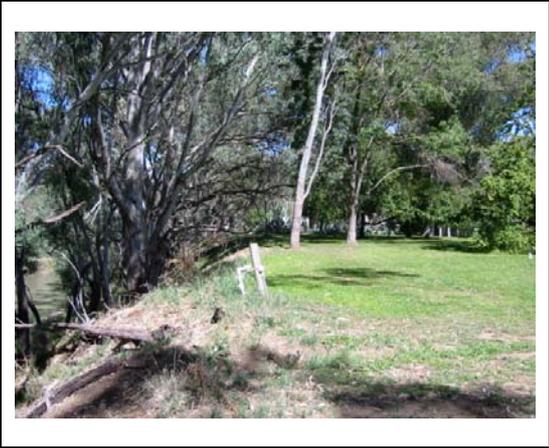
Site 2.9
Tenure Type – Unlicensed Crown Water Frontage

CWF Vegetation Quality Assessment	
Vegetation Width	1
Soil Disturbance	2
Tree Health	3
Tree Regeneration	3
Weed Presence	1
Species Richness	1
Vegetation Structure	1
Total	12

CWF Quality Class = **Very Poor**

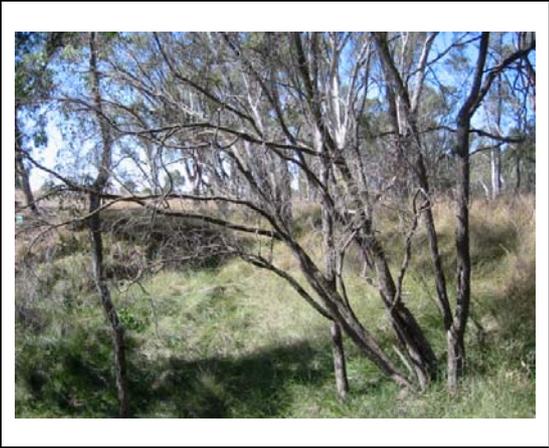
Site 2.10
Tenure Type – Unlicensed Crown Water Frontage

CWF Vegetation Quality Assessment	
Vegetation Width	5
Soil Disturbance	4
Tree Health	3
Tree Regeneration	2
Weed Presence	3
Species Richness	3
Vegetation Structure	3
Total	23

CWF Quality Class = **Good**

- Priority Actions to achieve Minimum Acceptable Standards:**
- Enforce existing legislation regarding littering and rubbish dumping
 - Ensure that unauthorised timber removal or timber harvesting does not occur
 - Implement revegetation programs to improve quality of native shrub layer
 - Develop grazing management plan for site to ensure that grazing by domestic stock does not compromise values of the site
 - Adjacent private land parcel contains similar, high values. Investigate measures to ensure that these values are retained, eg Conservation Covenant

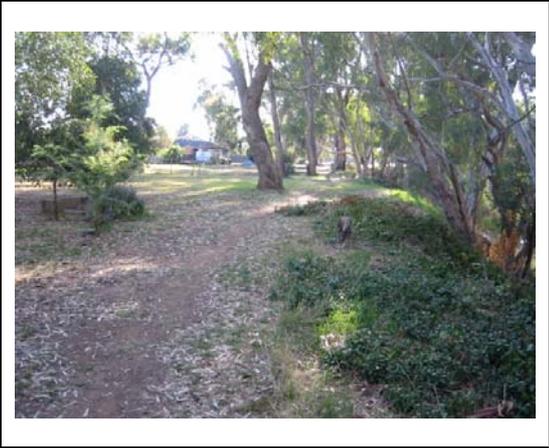
Site 3.1
Tenure Type – Unlicensed Crown Water Frontage

Within the study area there are several parcels that have not been delegated to other responsible authorities and where management responsibility is still vested with DSE-CLM. In these locations the absence of on ground management has led to sites being in moderate to poor condition such as Site 3.1.

CWF Vegetation Quality Assessment	
Vegetation Width	1
Soil Disturbance	3
Tree Health	3
Tree Regeneration	2
Weed Presence	1
Species Richness	1
Vegetation Structure	1
Total	12

CWF Quality Class = **Very Poor**

- Priority Actions to achieve Minimum Acceptable Standards:**
- Define public/private land boundary
 - Enforce existing legislation regarding littering and rubbish dumping
 - Manage weeds, particularly environmental weed species.
 - Control recreational activities particularly uncontrolled access to site
 - Ensure that unauthorised timber removal does not occur
 - Implement revegetation programs to improve quality of native understorey
 - Undertake community education program

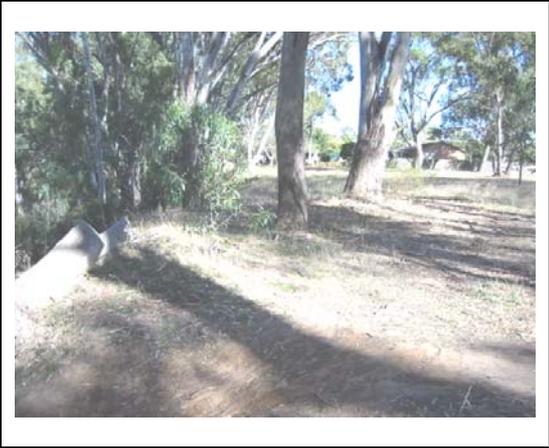
Site 3.2
Tenure Type – GSCC Committee of Management

CWF Vegetation Quality Assessment	
Vegetation Width	2
Soil Disturbance	2
Tree Health	3
Tree Regeneration	2
Weed Presence	2
Species Richness	3
Vegetation Structure	3
Total	17

CWF Quality Class = **Poor**

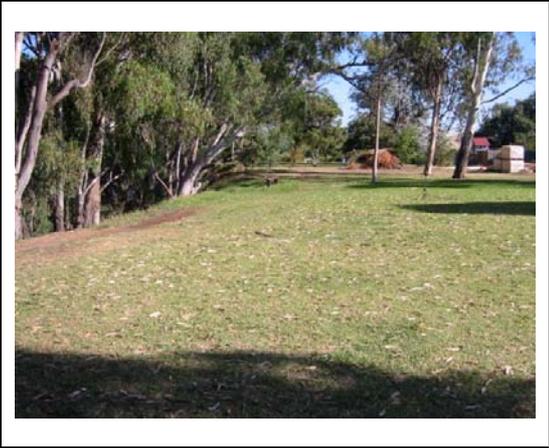
Site 3.3
Tenure Type – GSCC Committee of Management

CWF Vegetation Quality Assessment	
Vegetation Width	1
Soil Disturbance	2
Tree Health	3
Tree Regeneration	2
Weed Presence	1
Species Richness	2
Vegetation Structure	2
Total	13

CWF Quality Class = **Poor**

- Priority Actions to achieve Minimum Acceptable Standards:**
- Define public/private land boundary
 - Enforce existing legislation regarding littering and rubbish dumping
 - Manage weeds, particularly environmental weed species.
 - Control recreational activities particularly uncontrolled access to site
 - Ensure that unauthorised timber removal does not occur
 - Implement revegetation programs to improve quality of native understorey
 - Undertake community education program

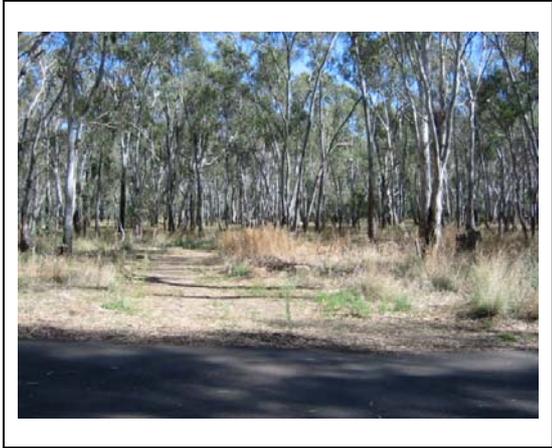
Site 3.4
Tenure Type – Unlicensed State Forest

CWF Vegetation Quality Assessment	
Vegetation Width	5
Soil Disturbance	3
Tree Health	2
Tree Regeneration	2
Weed Presence	1
Species Richness	2
Vegetation Structure	1
Total	16

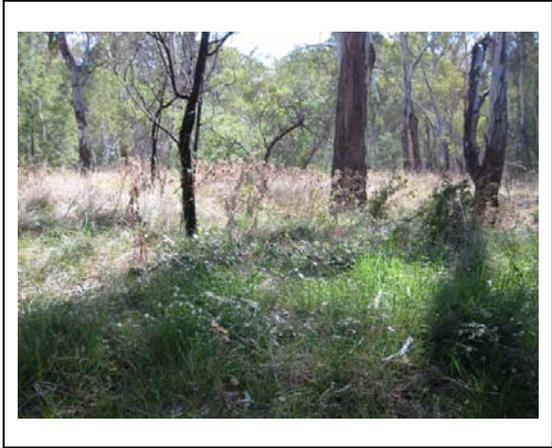
Site 3.5
Tenure Type – Unlicensed State Forest

CWF Vegetation Quality Assessment	
Vegetation Width	5
Soil Disturbance	3
Tree Health	3
Tree Regeneration	1
Weed Presence	1
Species Richness	2
Vegetation Structure	2
Total	17

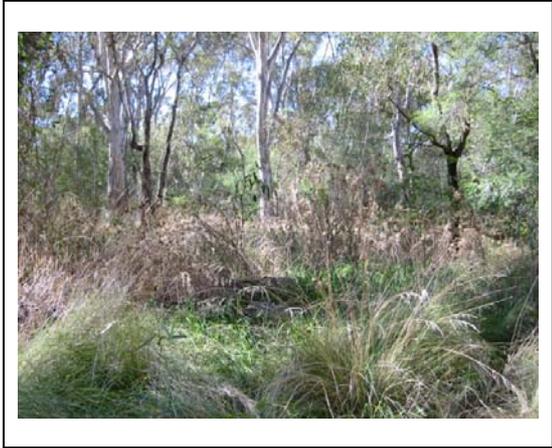
Site 3.6
Tenure Type – Unlicensed State Forest

CWF Vegetation Quality Assessment	
Vegetation Width	5
Soil Disturbance	4
Tree Health	3
Tree Regeneration	2
Weed Presence	1
Species Richness	1
Vegetation Structure	2
Total	18

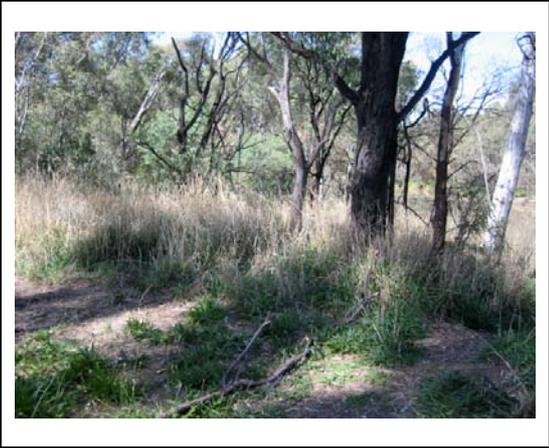
Site 3.7
Tenure Type – GSCC Committee of Management

CWF Vegetation Quality Assessment	
Vegetation Width	5
Soil Disturbance	2
Tree Health	2
Tree Regeneration	2
Weed Presence	1
Species Richness	1
Vegetation Structure	2
Total	15

CWF Quality Class = **Poor**

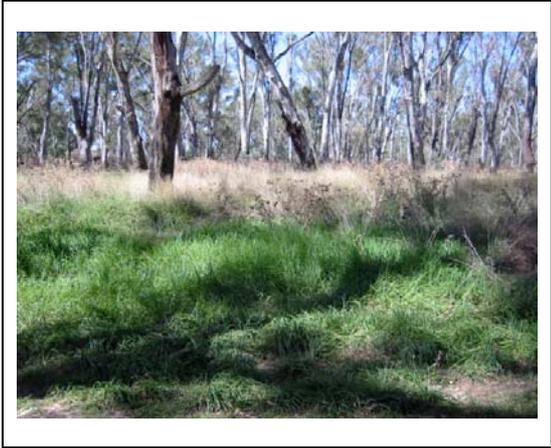
Site 3.8
Tenure Type – GSCC Committee of Management

CWF Vegetation Quality Assessment	
Vegetation Width	5
Soil Disturbance	2
Tree Health	2
Tree Regeneration	2
Weed Presence	1
Species Richness	1
Vegetation Structure	1
Total	14

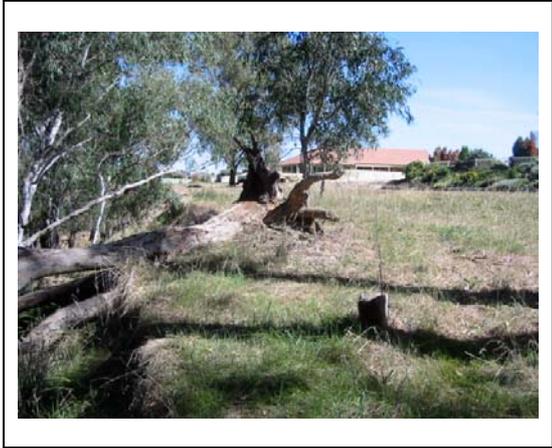
Site 3.9
Tenure Type – GSCC Reserve

CWF Vegetation Quality Assessment	
Vegetation Width	4
Soil Disturbance	3
Tree Health	2
Tree Regeneration	3
Weed Presence	1
Species Richness	3
Vegetation Structure	3
Total	19

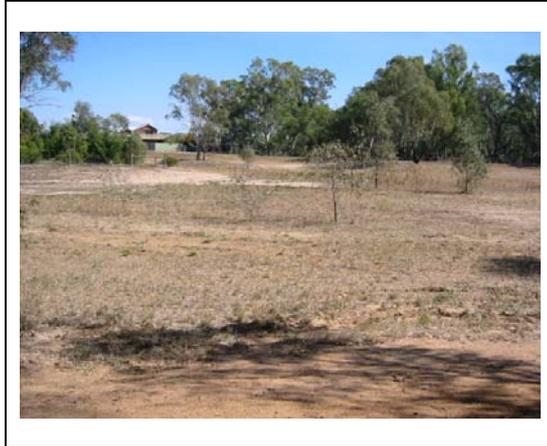
Site 3.10
Tenure Type – GSCC Reserve

CWF Vegetation Quality Assessment	
Vegetation Width	5
Soil Disturbance	1
Tree Health	4
Tree Regeneration	2
Weed Presence	2
Species Richness	3
Vegetation Structure	3
Total	20

CWF Quality Class = **Moderate**

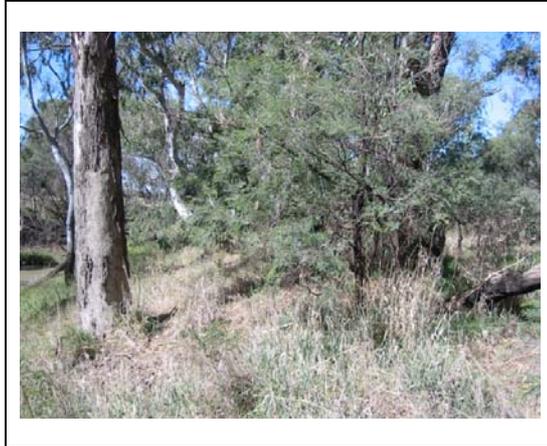
Site 3.11
Tenure Type – GSCC Reserve

Assessment Date: April 2005
Assessment Location (AMG): 356375 E 5969607 N

CWF Vegetation Quality Assessment	
Vegetation Width	5
Soil Disturbance	3
Tree Health	3
Tree Regeneration	2
Weed Presence	1
Species Richness	2
Vegetation Structure	2
Total	18

CWF Quality Class = **Poor**

- Define public/private land boundary
- Enforce existing legislation regarding littering and rubbish dumping
- Manage weeds, particularly environmental weed species.
- Control recreational activities particularly uncontrolled access to site
- Ensure that unauthorised timber removal does not occur
- Implement revegetation programs to improve quality of native understorey
- Undertake community education program

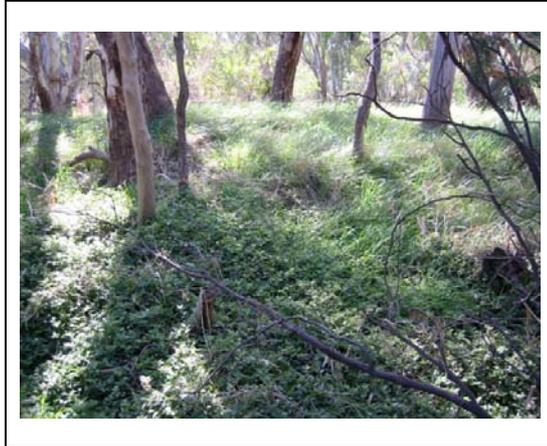
Site 3.12
Tenure Type – GSCC Reserve

Assessment Date: 6 April 2005
Assessment Location (AMG): 356878 E 5969236 N

CWF Vegetation Quality Assessment	
Vegetation Width	5
Soil Disturbance	4
Tree Health	3
Tree Regeneration	2
Weed Presence	1
Species Richness	2
Vegetation Structure	2
Total	19

CWF Quality Class = **Moderate**

- Enforce existing legislation regarding littering and rubbish dumping
- Manage weeds, particularly environmental weed species.
- Control recreational activities particularly uncontrolled access to site
- Ensure that unauthorised timber removal does not occur
- Implement revegetation programs to improve quality of native understorey
- Undertake community education program

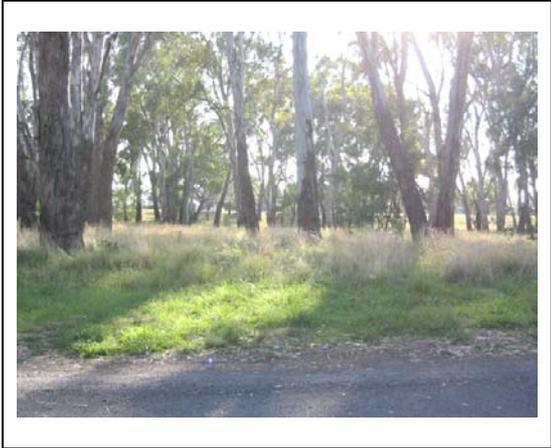
Site 4.1
Tenure Type – GSCC Committee of Management

CWF Vegetation Quality Assessment	
Vegetation Width	5
Soil Disturbance	2
Tree Health	2
Tree Regeneration	1
Weed Presence	2
Species Richness	2
Vegetation Structure	2
Total	16

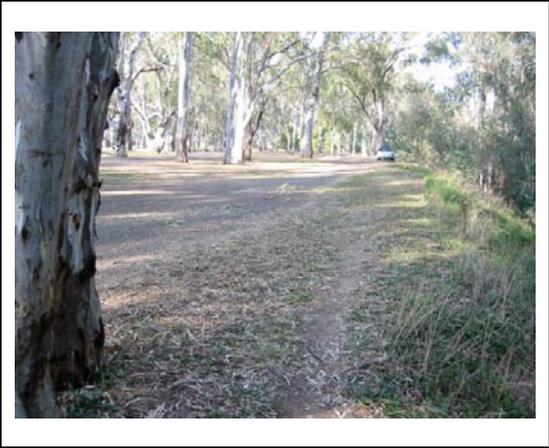
Site 4.2
 Tenure Type – GSCC Committee of Management

Assessment Date: 7 April 2005
 Assessment Location (AMG): 355730 E 5971400 N

CWF Vegetation Quality Assessment	
Vegetation Width	4
Soil Disturbance	1
Tree Health	2
Tree Regeneration	2
Weed Presence	1
Species Richness	2
Vegetation Structure	2
Total	14

CWF Quality Class = **Poor**

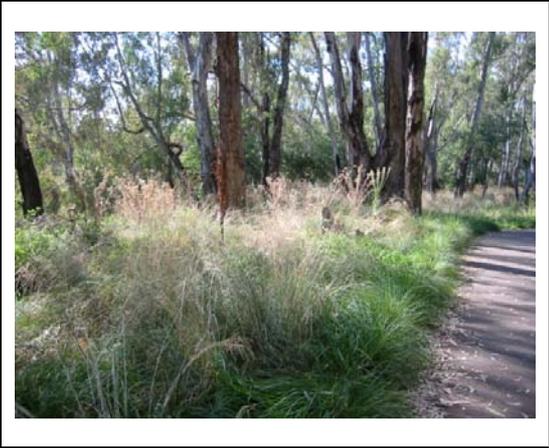
Site 4.3
 Tenure Type – Unlicensed Crown Water Frontage

Assessment Date: 7 April 2005
 Assessment Location (AMG): 355381 E 5971105 N

CWF Vegetation Quality Assessment	
Vegetation Width	5
Soil Disturbance	4
Tree Health	3
Tree Regeneration	1
Weed Presence	1
Species Richness	3
Vegetation Structure	2
Total	19

CWF Quality Class = **Moderate**

- Priority Actions to achieve Minimum Acceptable Standards:**
- Enforce existing legislation regarding littering and rubbish dumping
 - Manage weeds, particularly environmental weed species.
 - Control recreational activities particularly uncontrolled access to site
 - Ensure that unauthorised timber removal or timber harvesting does not occur
 - Implement revegetation programs to improve quality of native understorey
 - Ensure that grazing by stock continues to be excluded

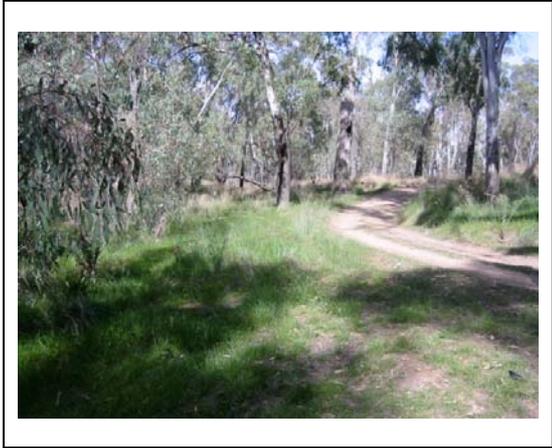
Site 4.4
Tenure Type – Unlicensed State Forest

CWF Vegetation Quality Assessment	
Vegetation Width	5
Soil Disturbance	3
Tree Health	3
Tree Regeneration	2
Weed Presence	2
Species Richness	3
Vegetation Structure	2
Total	20

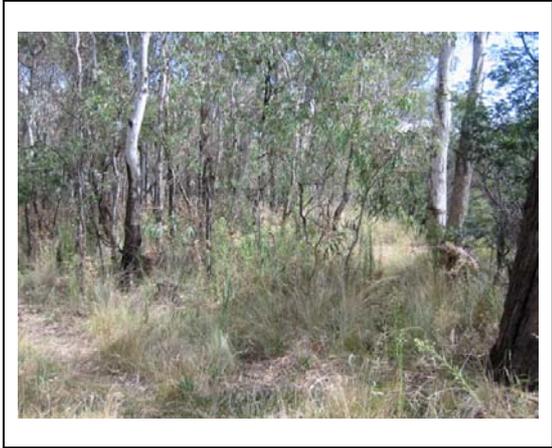
Site 4.5
Tenure Type – Unlicensed State Forest

CWF Vegetation Quality Assessment	
Vegetation Width	5
Soil Disturbance	4
Tree Health	3
Tree Regeneration	3
Weed Presence	2
Species Richness	4
Vegetation Structure	3
Total	24

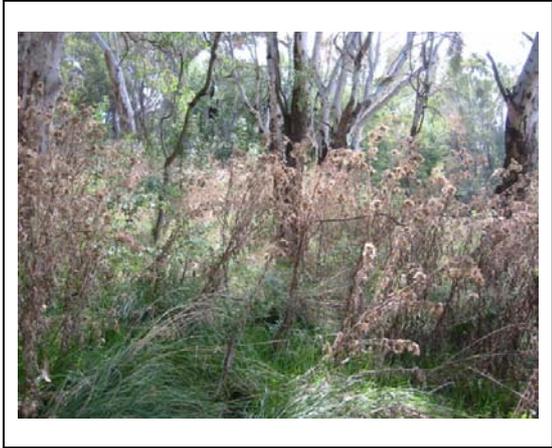
Site 4.6
Tenure Type – Unlicensed State Forest

CWF Vegetation Quality Assessment	
Vegetation Width	5
Soil Disturbance	3
Tree Health	3
Tree Regeneration	2
Weed Presence	1
Species Richness	2
Vegetation Structure	3
Total	19

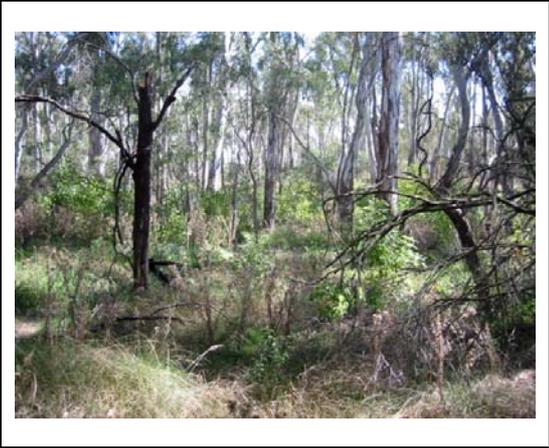
Site 4.7
Tenure Type – Unlicensed Crown Water Frontage

Assessment Date: 7 April 2005
Assessment Location (AMG): 353632 E 5971138 N

CWF Vegetation Quality Assessment	
Vegetation Width	5
Soil Disturbance	3
Tree Health	3
Tree Regeneration	2
Weed Presence	1
Species Richness	1
Vegetation Structure	2
Total	17

CWF Quality Class = **Poor**

- Priority Actions to achieve Minimum Acceptable Standards:**
- Enforce existing legislation regarding littering and rubbish dumping
 - Manage weeds, particularly environmental weed species.
 - Control recreational activities particularly uncontrolled access to site
 - Ensure that unauthorised timber removal or timber harvesting does not occur
 - Implement revegetation programs to improve quality of native understorey
 - Ensure that grazing by stock continues to be excluded

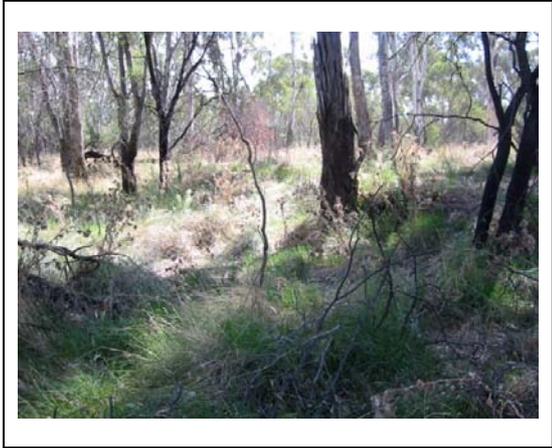
Site 4.8
Tenure Type – Unlicensed State Forest

CWF Vegetation Quality Assessment	
Vegetation Width	5
Soil Disturbance	4
Tree Health	3
Tree Regeneration	2
Weed Presence	2
Species Richness	3
Vegetation Structure	3
Total	22

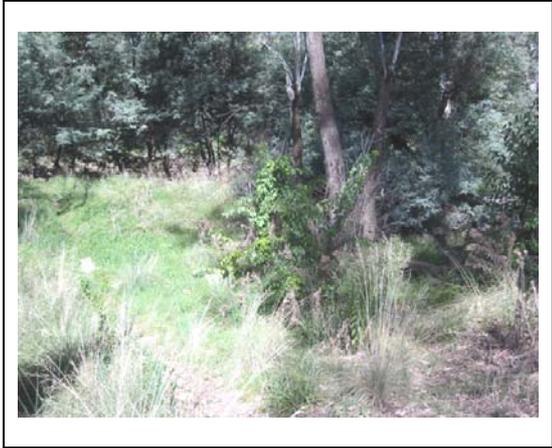
Site 4.9
Tenure Type – Unlicensed State Forest

CWF Vegetation Quality Assessment	
Vegetation Width	5
Soil Disturbance	2
Tree Health	2
Tree Regeneration	2
Weed Presence	1
Species Richness	2
Vegetation Structure	3
Total	17

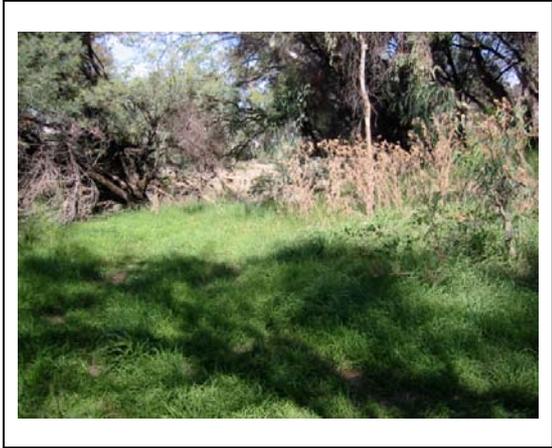
Site 4.10
Tenure Type – PV Managed Reserve

CWF Vegetation Quality Assessment	
Vegetation Width	5
Soil Disturbance	2
Tree Health	3
Tree Regeneration	2
Weed Presence	1
Species Richness	2
Vegetation Structure	3
Total	18
